Red on White Trail

Rope Tow to Lower Drummer Road

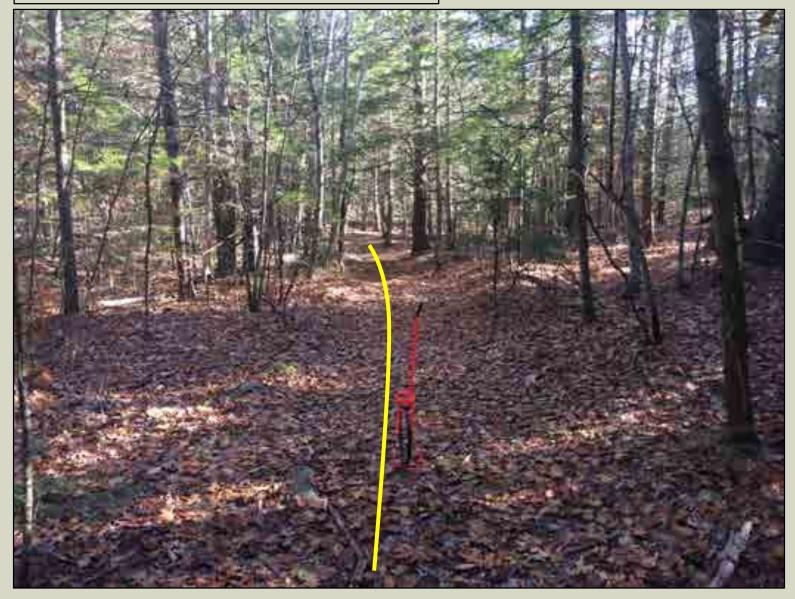
Photo 10

1251	1612	361	8	Trail climbs steeply.	Install grade reversals to shed water from treadway.	D, E, H
1612	1765	153	9	Trail climbs gradually.	Clear corridor and roots as needed, otherwise good tread.	D, E
1765	1765	0	10	Junction with Old Gilsum Rd.	Install signage at junction.

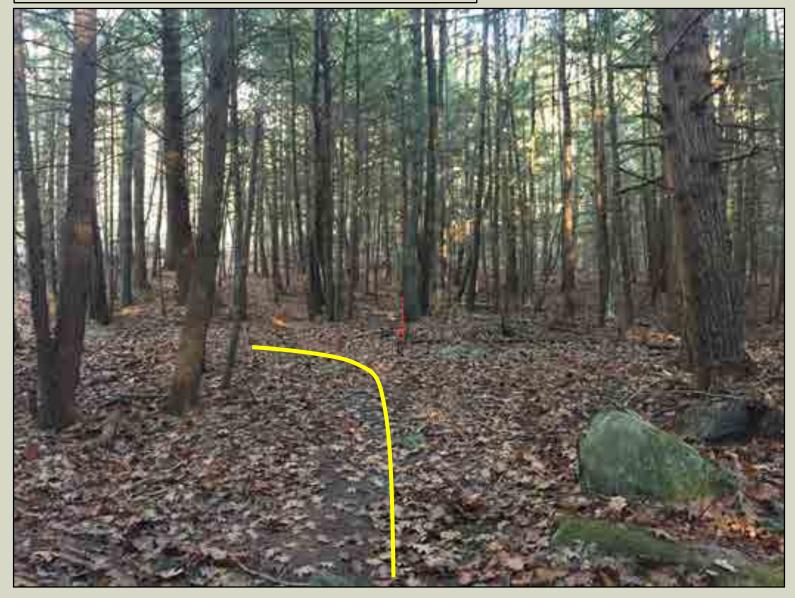
Photo 10

Begin	End	Length	Photo #	Reference Point	Design Directive	Spec #
3700	3857	157	9	Alignment begins to climb.	Clear corridor and outslope tread as needed, otherwise good tread.	D
3857	3857	0	10	Junction with Lower Drummer Rd, alignment turns left.	Signage needed.	D
3857	4058	201	11	"Goat" crosses alignment.	Clear corridor and outslope tread as needed, otherwise good tread.	D, E
4058	4682	624	12	Continue on existing alignment.	Clear corridor and outslope tread as needed, otherwise good tread.	D, E
4682	4682	0	12	Junction with "Threader" to left.	Clear corridor and outslope tread as needed, otherwise good tread.	D, E
4682	5,151	469	13	Continue on existing alignment.	Clear corridor and outslope tread as needed, otherwise good tread.	D, E
5151	5,151	0	13	Conservation Area Boundary, coppice oak on left.	Clear corridor and outslope tread as needed, otherwise good tread.	D, E
5151	5464	313	14	Alignment reaches edge of powerline corridor.	Align trail on existing tread, clear corridor and roots as needed	D, E
