# Greater Goose Pond Forest

## Trail Assessment and Design Plan

*City of Keene  
Planning Department  
3 Washington Street  
Keene, NH 03431*

**August 22, 2018 by:**

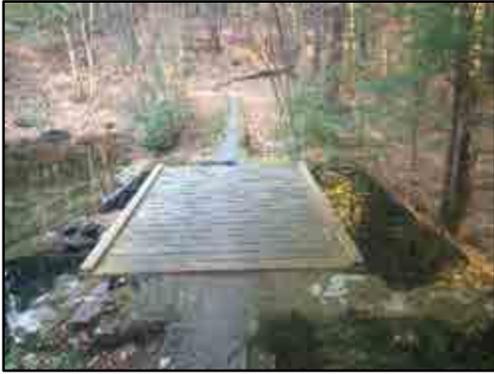
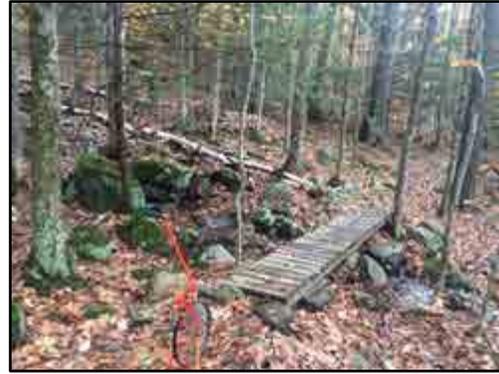
Although the tread of the NEMBA trails was constructed with sustainability in mind, it is recommended to encourage a similar attention to detail on the bridge structures. A bridge was installed by the lower pond that has a drop of 8 feet with no railings. Additionally, many of the smaller bridges are built within active waterways with high flows that can and have displaced the bridges. As noted in the Construction Specifications at the end of this document, we recommend using non pressure treated lumber for the decking as pressure treated lumber becomes quite slippery when wet. Additionally, and where possible, anchoring the bridge sills to base stones will help them remain in place during high water events.

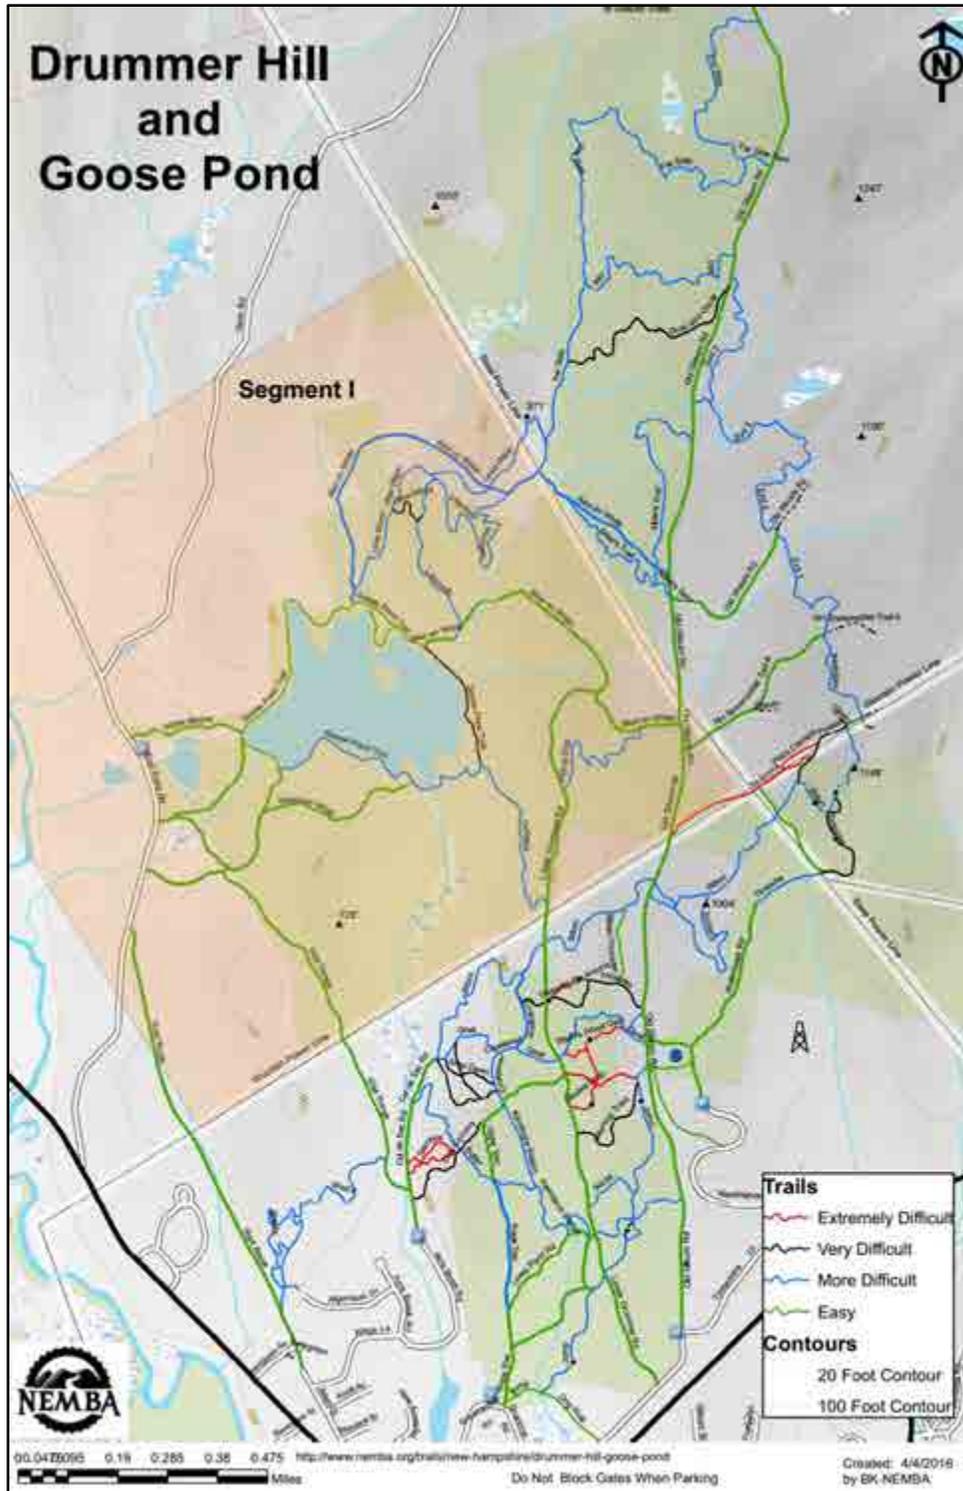
Segment one, shaded in orange, is the most visited portion of the Greater Goose Pond Forest trail system. The main access point is the parking lot off East Surry Road. Trails are varied in their width and character. Suggested improvements include replacement of trail bridges, small reroutes, signage, and the incorporation of an accessible trail with a view of the lower wetland area.

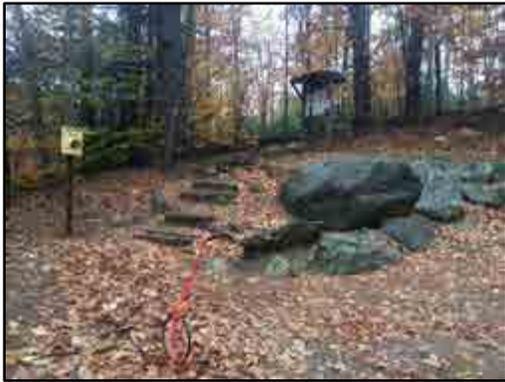
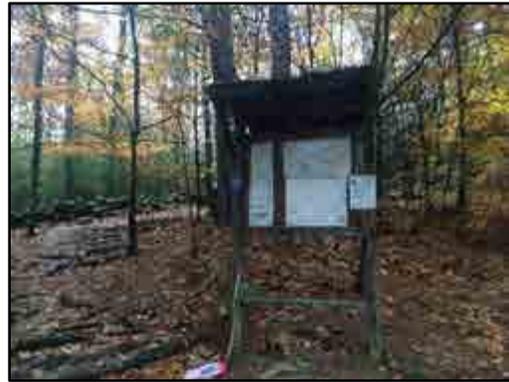
The Entrance Trail, marked by White Blazes, introduces users to the property by way of rotted timbers, exposed rebar, steep grades, and a failing kiosk. Roots have been exposed due to years of use and erosion. Given the layout of the parking lot, it is suggested to relocate this trail to the other side of the parking lot. This report encourages moving the entrance trail to the right hand side of the parking lot and upgrading its condition to include stone steps, a curvilinear design, and a new kiosk. These tasks are outlined in the attached Trail Log and Photopages.

Currently, there are two entrance trails that eventually merge and lead to Goose Pond. The original trail leaves the left hand corner of the parking lot and climbs up steep slopes over exposed roots and marches on towards the pond. Timber & Stone, LLC strongly suggests closing this trail due its unsafe and unsustainable condition.

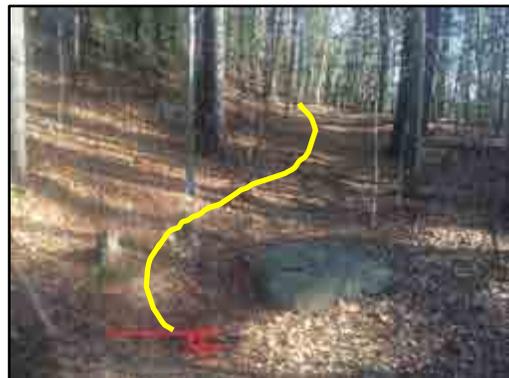
This new approach to the entrance trail has gentler grades, is more welcoming, and is currently the path most trail users choose for accessing the property. Additionally, there is an ideal spot for the kiosk that is more visible to all users.

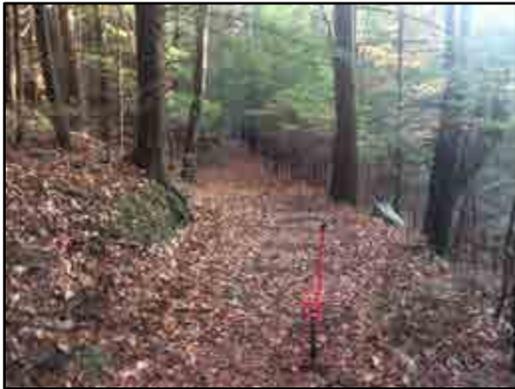
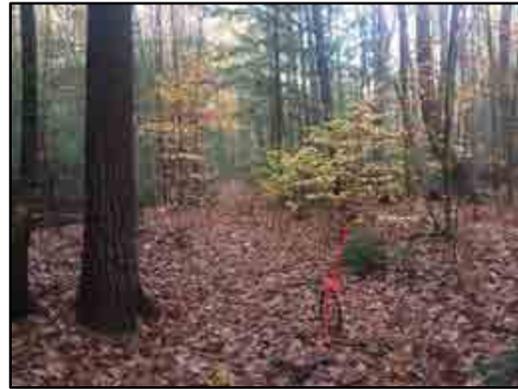
This trail is slated to be an access road for the maintenance of the Goose Pond dams. Prior to learning of that fate, Timber & Stone, LLC had assessed the trail with an intent of suggesting it be turned into a multi-use pathway for bikes and pedestrians. This would allow for visitors to park at the new parking area to be built off East Surry Road and bike to the pond along this 2/3 mile trail. Given that it will be used for maintenance, it is our suggestion to construct and leave the road with the intent of having it be a multi-use bike pathway. Characteristics of that trail are found below:

The tread and corridor are integral components of a trail. The Green on White trail should maintain an 8' wide tread wherever possible and a corridor that is 10-12' wide and 8-10' high. Note the importance of the trees alongside the trail that add structure and character to the trail experience. Not all trees need to be removed in order to maintain an adequate trail corridor.

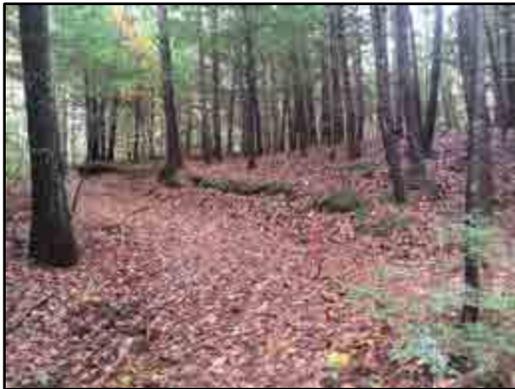
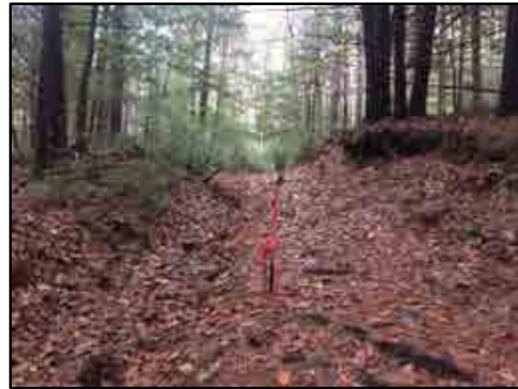
This trail veers left off the first intersection along the Lower Green and White Trail. We encourage the closing and rehabilitation of this trail corridor due to its steep grades, heavy erosion, and unsafe condition. With the use of the Lower and Upper Green and White trail as a multi-use pathway, this trail will become obsolete.

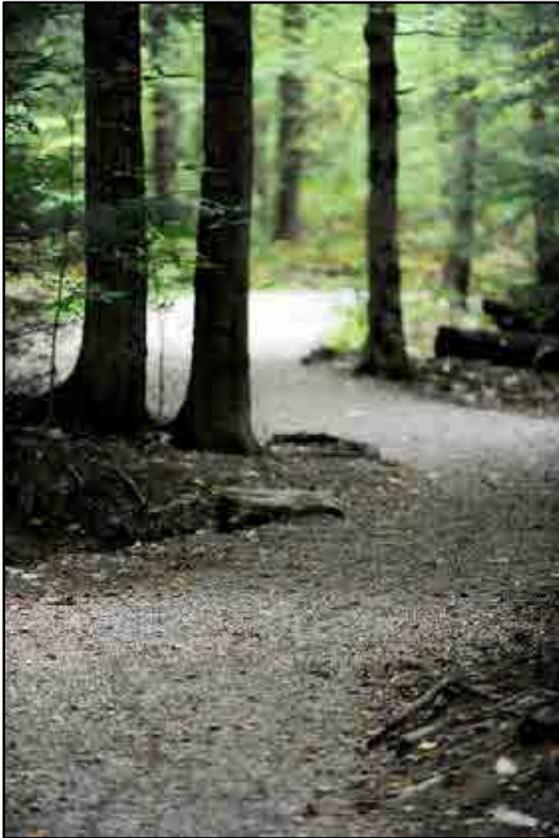
This Accessible Pathway was constructed to be curvilinear in design, similar to what is proposed for the Greater Goose Pond Forest Accessible Trail.

Mature trees are left to allow the trail meander between them while maintaining a naturalistic experience to visitors. The trail will maintain a consistent 5' width throughout.

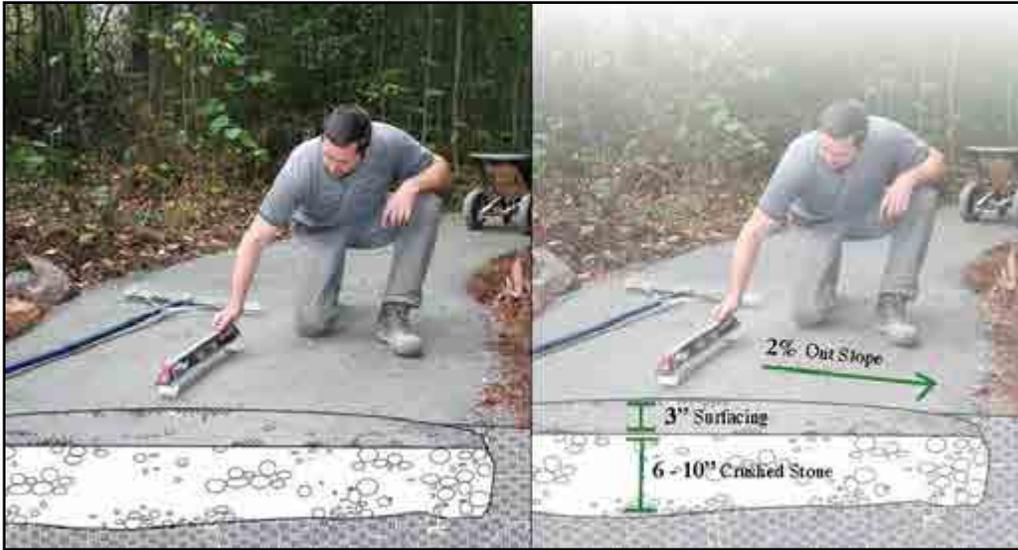
Outslope is an essential component of sustainable trail construction. This figure outlines the cross section of a naturally surfaced trail. After the initial excavation and installation of 6-10" of crushed stone as needed, non-woven geotextile fabric is installed. This prevents the migration of surfacing into the crushed stone. The 3/8" minus crushed stone surfacing is installed to a 4-6" depth. The surfacing is then graded using a 4' wide landscape rake to attain a 3-5% outslope. Compaction of the surfacing with a vibratory roller will reduce the outslope to an acceptable 2%. As seen in the figure, the running grade and outslope is checked using a digital smartlevel.

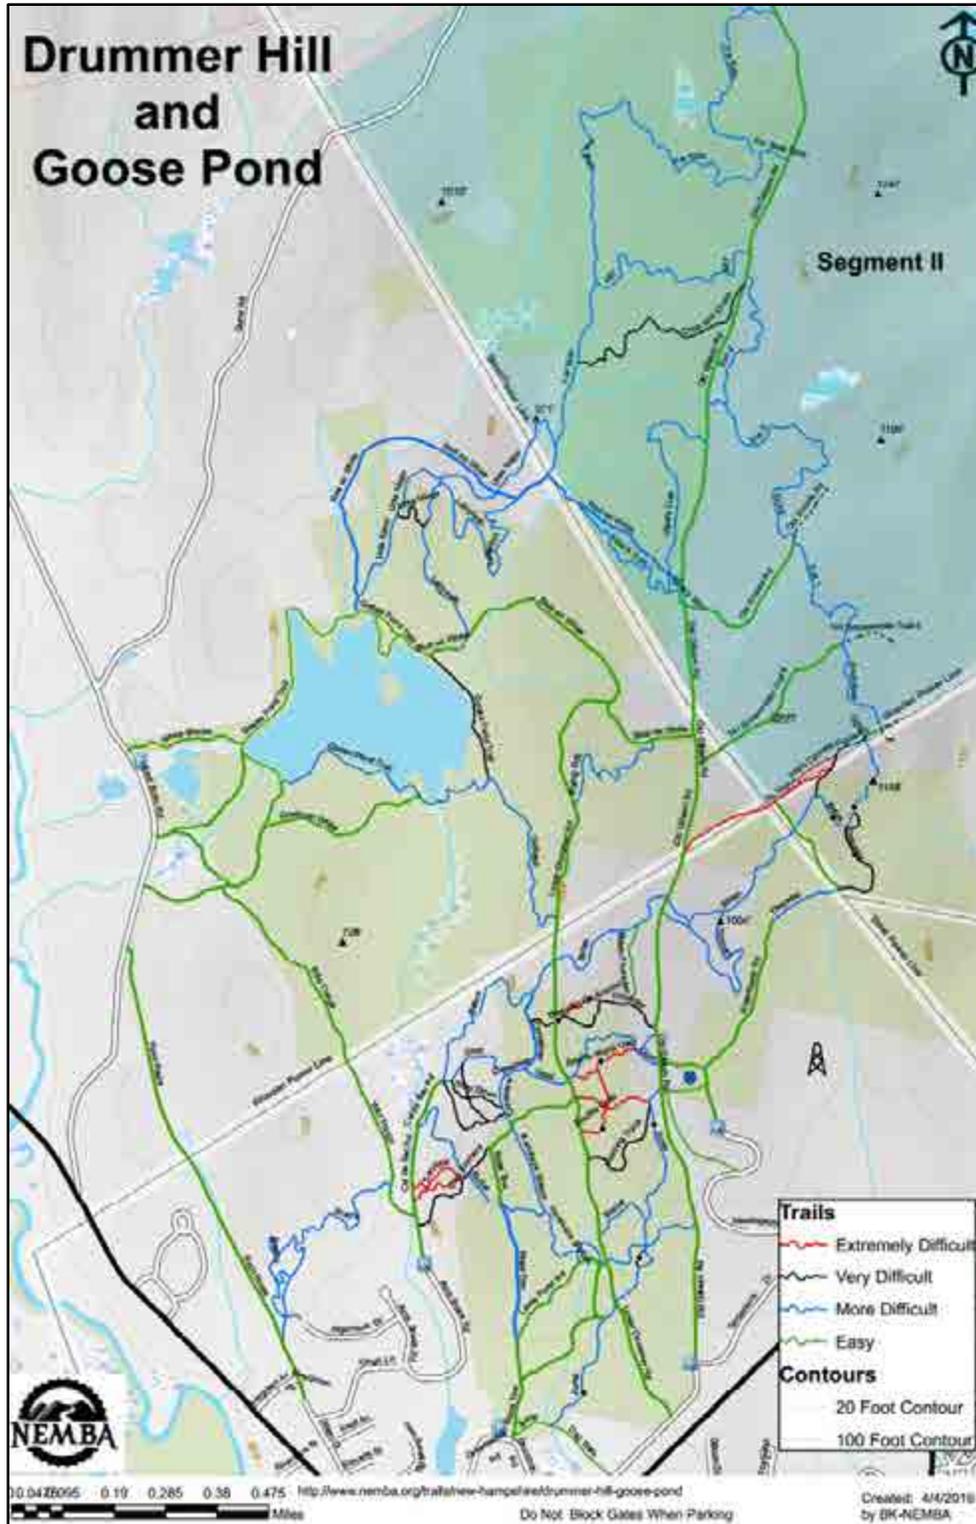
Segment two, shaded in blue, receives less visitation than the other two segments. Dense stands of Oak trees and exposed ledges are among the many natural features worth exploring.

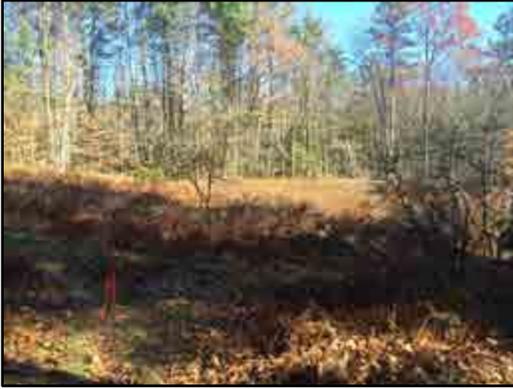
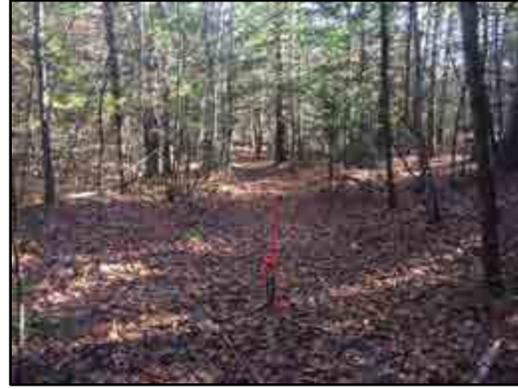
This trail provides connection from the intersection with Far Side up to Old Gilsum Road. Ultimately, the Red on White trail connects Old Gilsum Road with Goose Pond Trail. But, a majority of the trail is located on private land and has an impressive level of erosion and challenging terrain. The trail log and photopages found in this document focus on the upper section that is found within Segment II.

This trail provides a good connection along a preexisting road that may have been used for farming and logging at one point. As such, it does need drainage swales installed to maintain the tread. These structures, as prescribed in other trails within the property, may not be appreciated by mountain bikers as they can prove to be bothersome when traveling downhill.

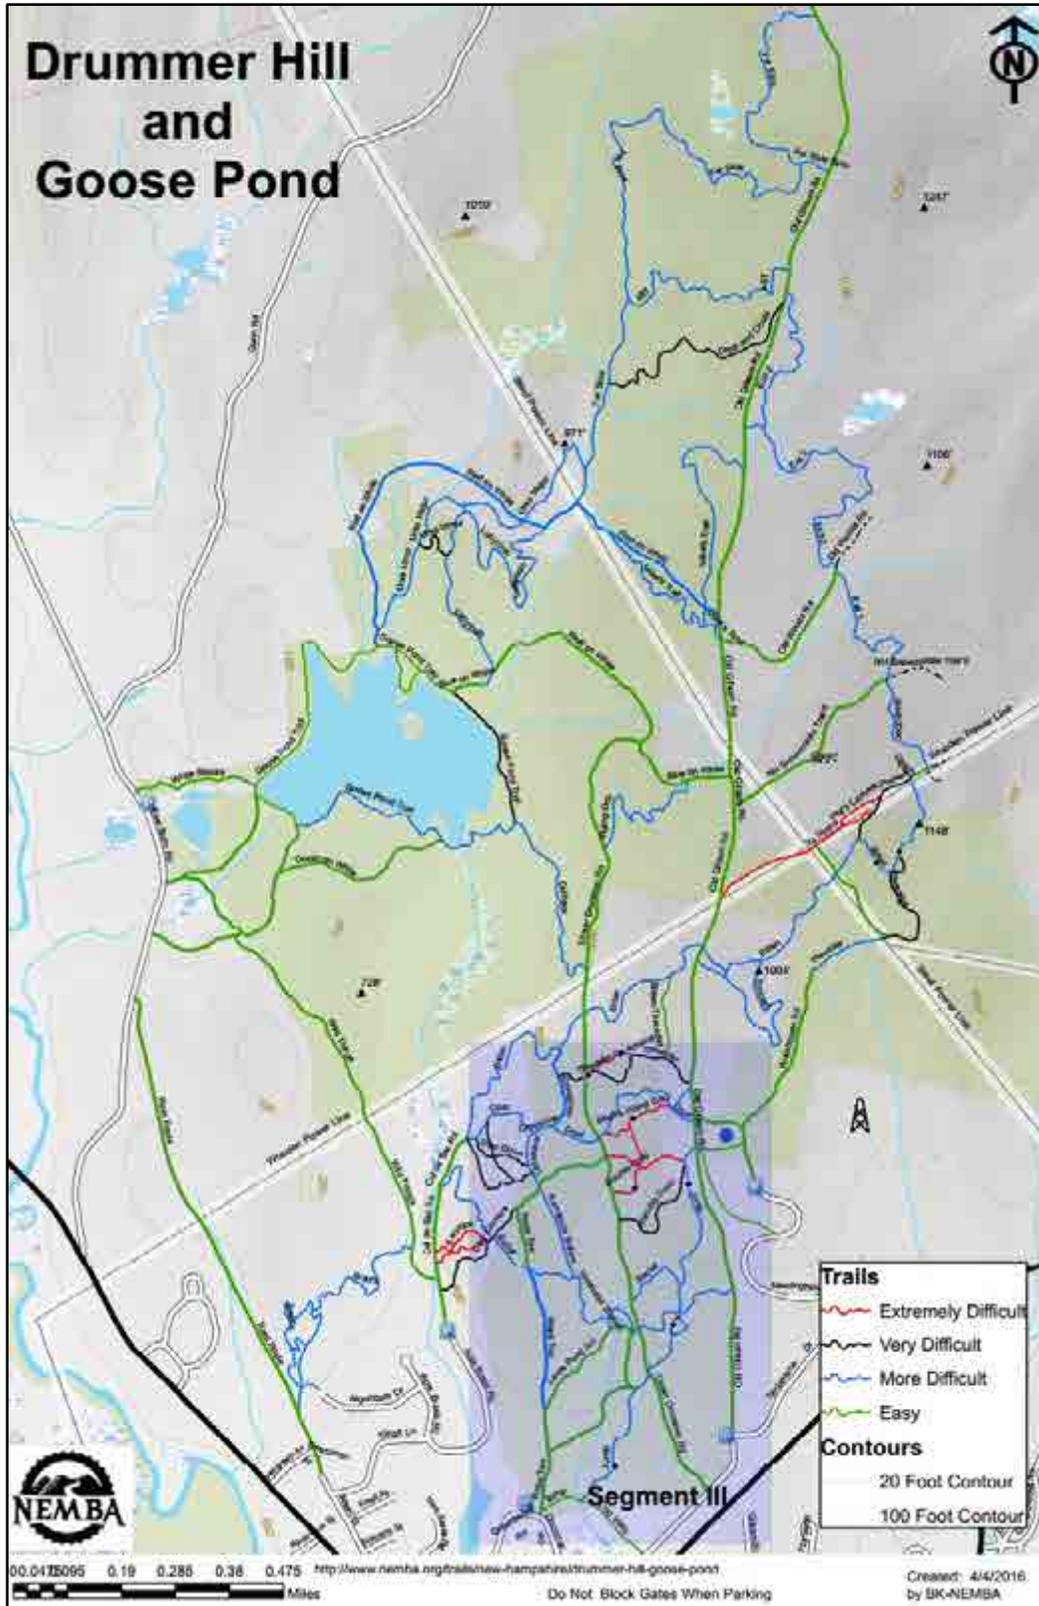
Segment III, shaded in purple, is frequently accessed by the current Drummer Road, the original Drummer Road, and a parking area at Timberlane Drive.

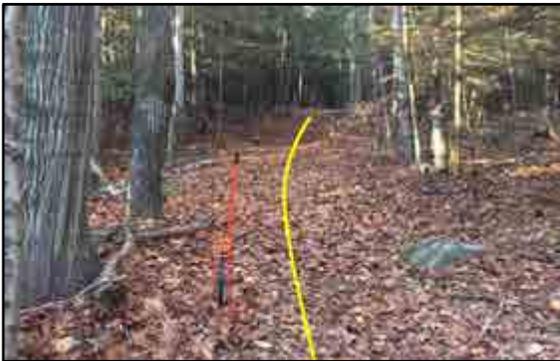
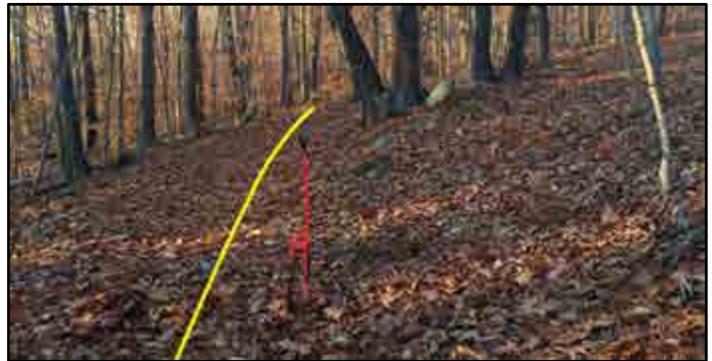
Similar to other trails on the property, this one shares the corridor of old logging and farming roads. Most of the trail repairs involve brushing the trail and removing the downhill berm to improve drainage. This trail provides connectivity towards Goose Pond for those who do not wish to use Old Gilsum Road.

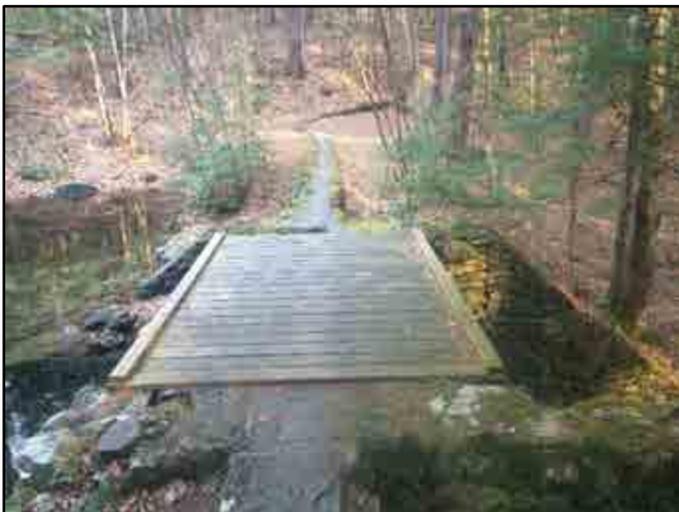
This bridge located in Segment III was constructed on railroad tracks and is perched over 8 feet above ground on the downhill side.

Without railings and with pressure treated decking, it poses a significant safety risk. We would recommend removing and replacing the bridge with structurally sound material.
