## **Upper Blue on White Trail**

# **Project:** Greater Goose Pond Forest **Location:** Keene, NH

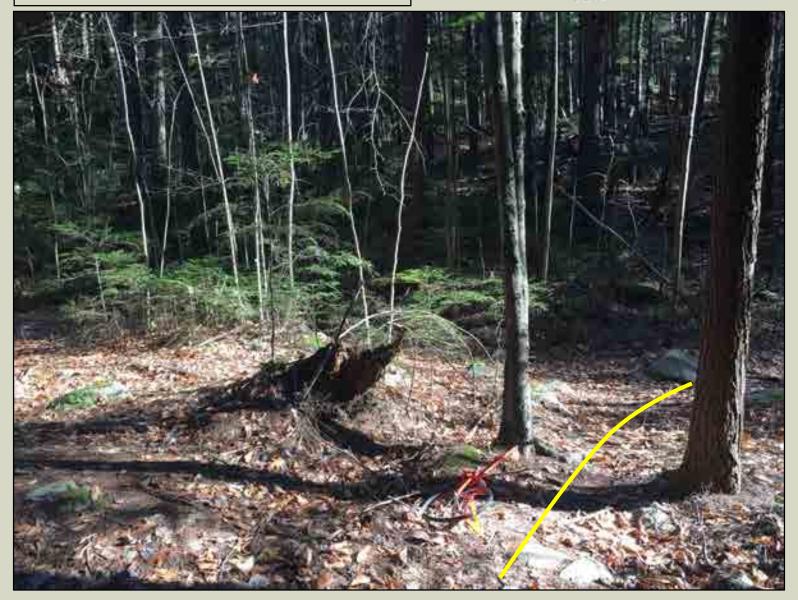
Begin	End	Length	Photo #	Reference Point	Design Directive	Spec #
0	0	0	1	Junction with "Lower Drummer Rd".	Turn right and cross drainage.	
30	73	43	2	Low and wet area of tread.	Elevate tread through drainage.	A, C, D, E
73	218	145	3 and 4	Trail veers left and begins to climb steeply, Hemlock saplings line treadway.	Reroute a climb route to right for bikers, current alignment is downhill only.	D, E
218	607	389	5	Hemlock saplings line trail.	Clear corridor as needed, otherwise good tread.	D
706	706	0	6	Intersection with "Flying Dog"	Clear site lines for safety and improve signage.	D
706	1120	414	7	Large stone in treadway.	Clear corridor as needed, otherwise good tread.	D
1120	1120	0	8	Junction with Old Gilsum Road	Install signage or secondary kiosk.

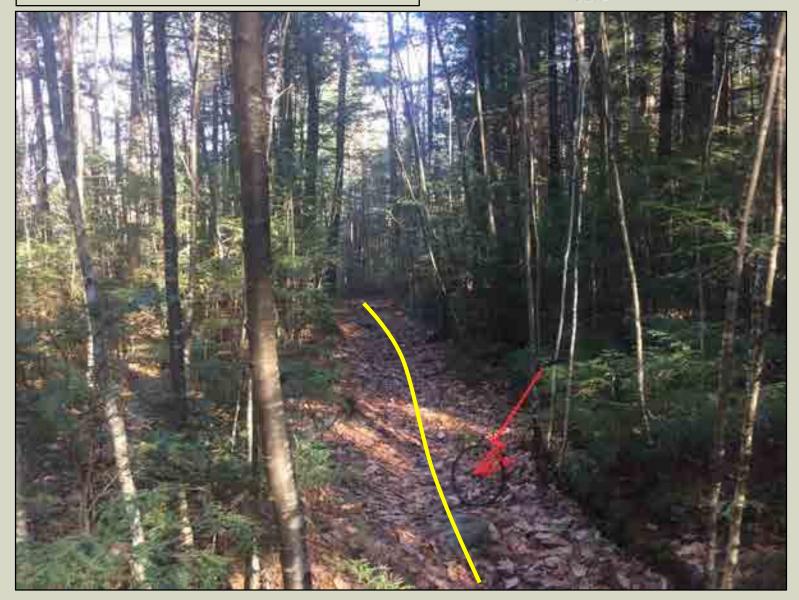
Begin	End	Length	Photo #	Reference Point	Design Directive	Spec #
0	261	261	1	Junction to Old Gilsum Rd to right. Alignment is cupped and begins to descend downhill.	Clear corridor and outslope tread.	D, E
261	278	17	2	Stream crossing.	Install 20' boardwalk uphill of existing boardwalk and realign trail.	В
278	316	38	3	Rocky and wet treadway.	Install stone cribbing and elevate tread.	A, E
316	495	179	4	Deadfall in treadway.	Clear deadfall, crib and fill tread as needed.	D, E
495	541	46	5	Cupped and wet trail.	Elevate tread with crush and fill. Clear corridor as needed.	A, D, E
541	672	131	6	Trail begins to descend hill.	Clear corridor and outslope tread as needed, otherwise good tread.	D, E
672	691	19	7 and 8	Water running in treadway, coppice hemlock to left.	Install stone pitching through wet area.	C, D
691	731	40	9	12" White Birch to left.	Clear corridor and outslope tread as needed, otherwise good tread.	D, E

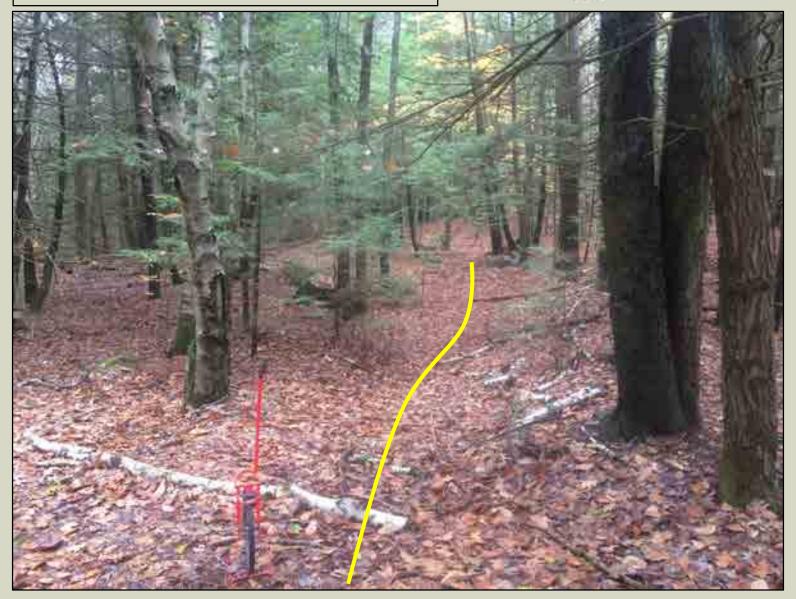
Begin	End	Length	Photo #	Reference Point	Design Directive	Spec #
0	183	183	1	Junction with Lower Future Service Rd, trail receives little use.	Clear corridor and roots, define tread.	D, E
183	183	0	2	Deadfall in trail.	Clear deadfall and continue to define tread.	D, E
183	430	247	3	Trail curves to right, existing grade reversal, ruts in treadway.	Level ruts, maintain grade reversal, and continue to clear corridor and roots.	D, E
592	758	166	4	Trail descends long even grade.	Install drainage and drain to left.	D, E
1079	1079	0	5	Black birch on right of alignment.	Clear corridor and roots, define tread.	D, E
1079	1302	223	6	Vernal pool to left.	Clear corridor and roots, define tread.	D, E
1458	1478	20	7	Seep running from right to left.	Install bridge or double culvert through wet area.	B, D, E, F
1493	1547	54	8	Large stone in center of alignment, low tread.	Remove boulder and elevate tread.	D, E, J

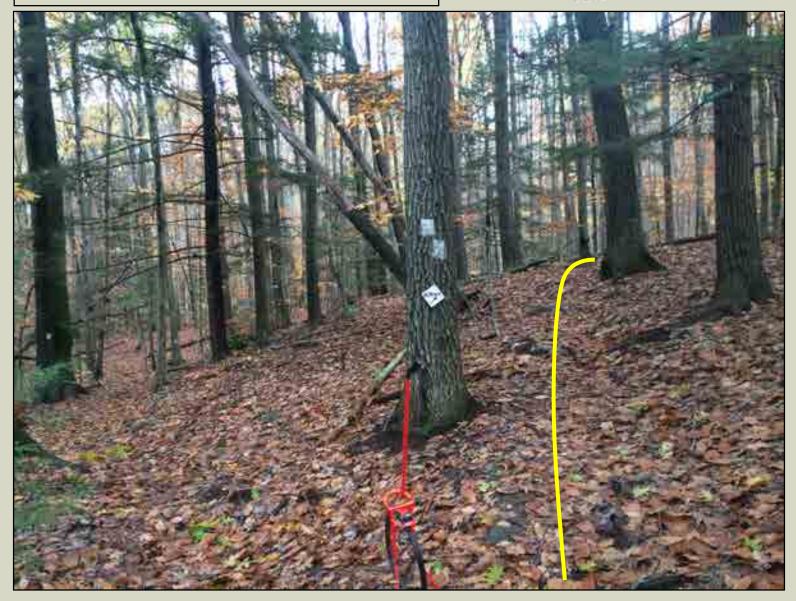
Begin	End	Length	Photo #	Reference Point	Design Directive	Spec #
0	0	0	1	Junction with Pond Loop Trail.	Clear corridor and roots as needed, good tread.	D
0	258	258	2	Trail climbs uphill, brush in treadway.	Clear brush in treadway, otherwise good tread	D
495	495	0	3	Pinch points between two oaks.	Clear corridor and roots as needed, good tread.	D, E
845	871	26	4	Existing bridge across stream.	Consider replacing decking with non-pressure treated lumber and anchoring bridge.	
1002	1002	0	5	Pinch point between stone and large Red Oak. Water in tread	Clear berm on right to improve drainage.	E
1145	1191	46	6	Cupping of treadway.	Knock down berm on right to improve drainage. Otherwise good tread.	E
1255	1255	0	7	Trail climbs steeply, 18" Red Maple on right	Install grade reversal up-hill on Red Maple to shed water off treadway.	н
1255	1382	127	7	Trail continues to climb.	Clear corridor and roots as needed, good tread.	D

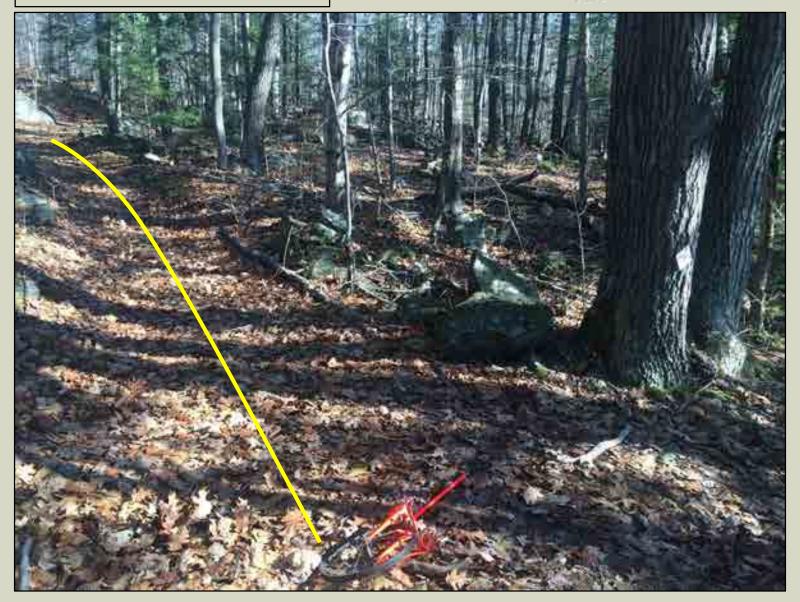
Begin	End	Length	Photo #	Reference Point	Design Directive	Spec #
0	0	0	1	Junction with Pond Loop Trail, coppice Oak on right.	Align trail on existing tread.	
0	205	205	2	Trail climbs steeply.	Bench right side of alignment and ditch left side. Consider reroute on cross slope to right.	E
205	205	0	3	Junction with "Blue on White".	Veer right at junction and align trail on existing tread.	D
205	460	255	4	Coppice oak on right, height of land.	Clear corridor and roots as needed, otherwise good tread.	D
533	533	0	5	Second junction with "Blue on White"	Cross "Blue on White" and continue uphill on existing tread.	D
533	826	293	5	Trail climbs uphill.	Clear corridor and roots as needed, otherwise good tread.	E
826	826	0	6	Coppice oak on right, height of land, boulders on either side of trail.	Level treadway and clear corridor as needed.	D, E
880	880	0	7	Trail veers left, lots of stones in treadway.	Clear stones and level tread to define treadway.	D, E

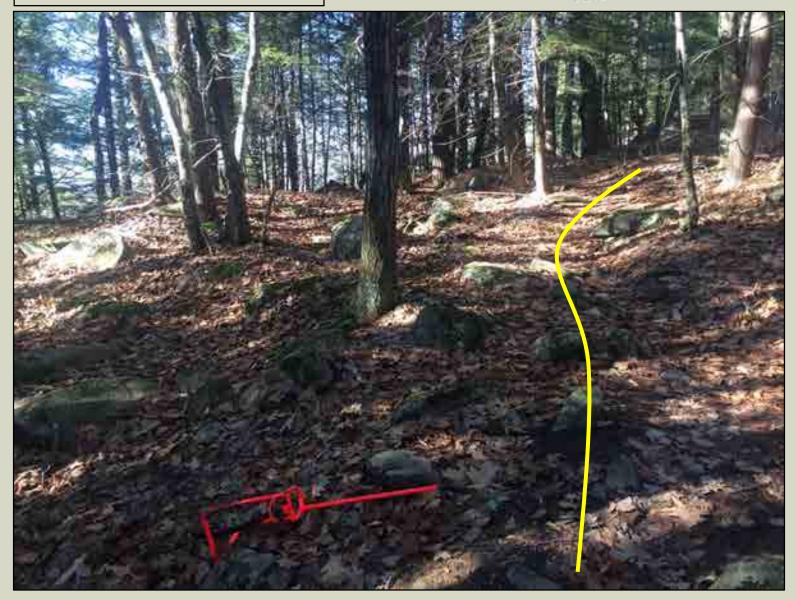
880	1030	150	8	Trail follows ridge, views to left.	Clear corridor and level tread as needed, otherwise good tread.	D, E
1030	1166	136	9	Exposed bedrock, pinch points	Level treadway and clear corridor as needed.	D

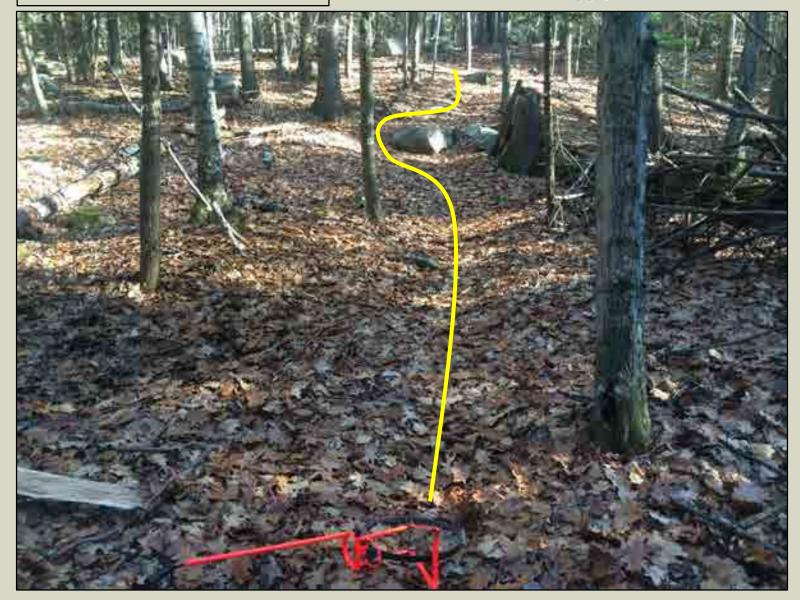
Begin	End	Length	Photo #	Reference Point	Design Directive	Spec #
1166	1166	0	10	Alignment veers right and begins to climb steeply.	Clear corridor and roots as needed, monitor erosion.	D
1166	1985	819	11	Trail climbs steeply toward ridge.	Clear corridor and define tread, monitor erosion.	D
1985	1985	0	11	Top of ridge.	Clear corridor and roots as needed, otherwise good tread.	D
1985	2666	681	12	Cross stone wall.	Clear corridor and roots as needed, otherwise good tread.	D
2666	2973	307		Trail climbs uphill, poorly defined tread.	Define tread and clear corridor as needed.	D
2973	3,080	107	13	Trail levels.	Clear corridor and roots as needed, otherwise good tread.	D
3080	3,080	0	13	Junction with "Red on White"	Trail ends at junction.

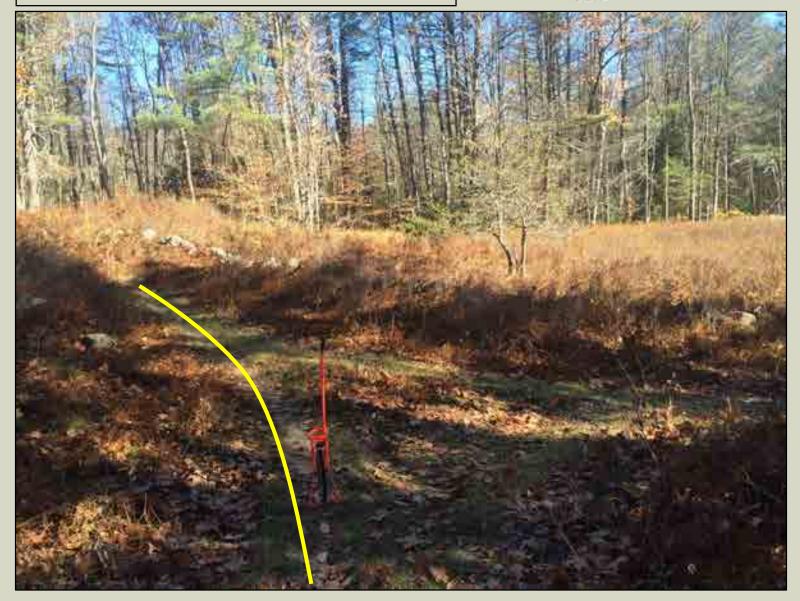
Begin	End	Length	Photo #	Reference Point	Design Directive	Spec #
0	0	0	1	Edge of powerline corridor. "Mike's Trail" to right and "Far Side" to left.	Install secondary kiosk.	
0	205	205	1	Alignment crosses powerline corridor.	Align trail on existing tread and remove roots as needed.	D,K
205	353	148	2	Alignment enters woods and continues on cross slope.	Clear corridor and roots as needed, otherwise good tread.	D, K
353	353	0	3	Junction with "Urea Major" to left, 20" Pine to right.	Clear corridor and roots as needed, otherwise good tread.	D
512	583	71	4	8" Maple on left.	Re-bench trail to define treadway. Clear corridor and roots as needed.	D, K
846	1131	285	5 and 6	Alignment drops downhill.	Outslope tread and drain to right.	D, K
1131	1177	46	7	Pinch point between two boulders. Wet area in tread.	Install stone pitching through wet area.	C, D
1186	1222	36	8	Stream crossing.	Elevate and extend stone pitching above waterline.	C, D

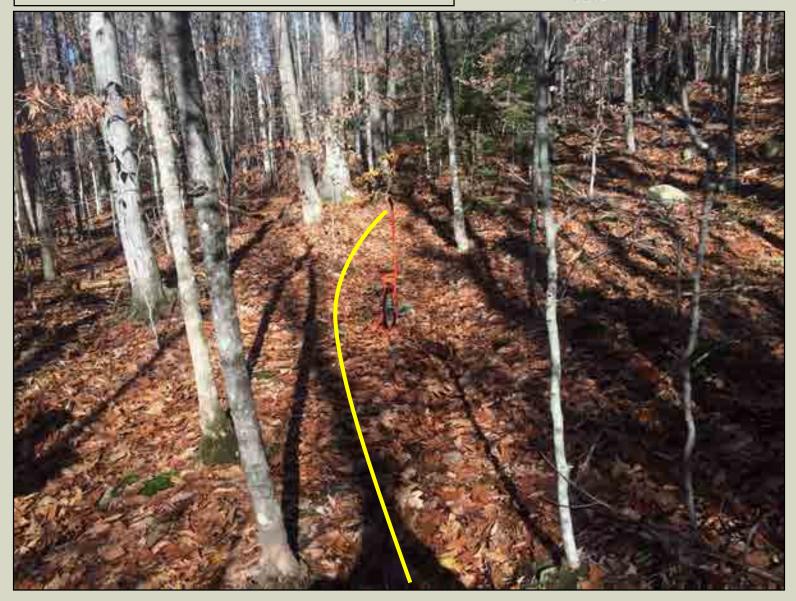
1298	1298	0	9	Junction with "Drops and Chutes" to right.	Clear corridor and roots as needed, otherwise good tread.	D
1375	1398	23	10	Wet area in tread.	Elevate tread through wet area.	A, C, D
